## 3D PHOTOGRAMMETRY APPLICATION FOR BUILDING INSPECTION OF CULTURAL HERITAGE OBJECTS

MARKOVA M.<sup>1</sup>, *Cand. Sc. (Tech.)*,

KRAVCHENKO D.<sup>2</sup>, *engineer*

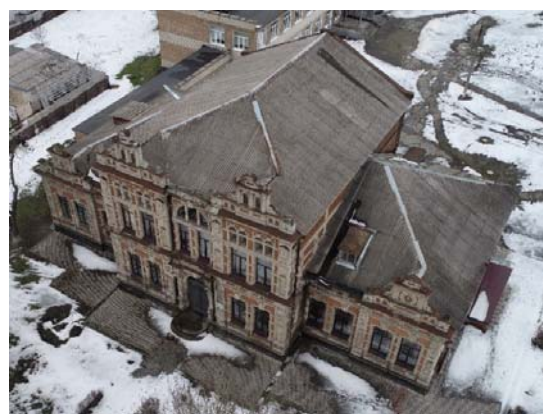
*Fig. 1. Aerial overview of the building*

The building was built in 1895 and at the time of the inspection, it fully functions as a school (Fig. 1). Since its construction, a minor architectural replanning, replacement of roofing materials, replacement of the heating system have been implemented. Basement, in general, remained unchanged. In this case, structural elements of the building were not affected. However, over a long period of time, destruction occurred: the structures underwent some damage and deformation, the finishing layers were dilapidated.

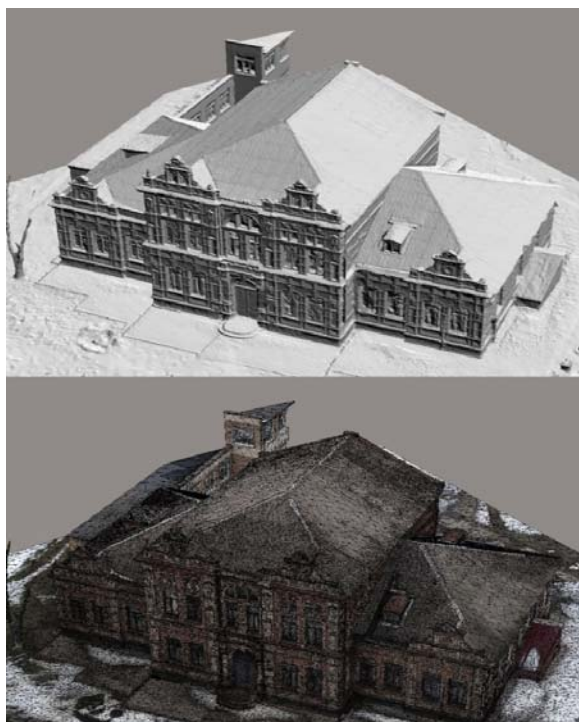
Fig. 5. – Textured and untextured result models

3D model was created with Autodesk Recap Photo software (ex- Autodesk Remake) in two variations – dense point cloud and high accurate polygonal textured mesh (Fig. 4, 5).

Damaged areas of the roof coating have been precisely identified through studying 3D textured mesh model in terms of both quantity and quality, which is challenging to do with traditional methods of inspection.

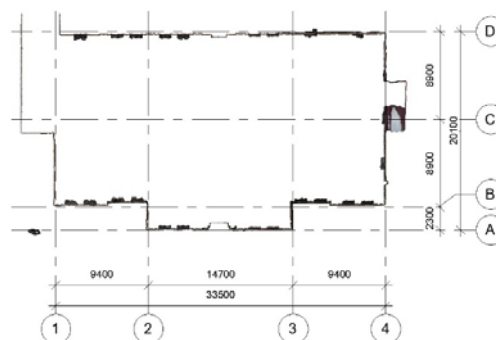
Fig. 7. Plan view

The obtained model was successfully used for documentation of structural and architectural elements and the building itself. Main drawings of existing building were semi-automatically created in Autodesk Revit BIM software with the help of background 3D point cloud model (Fig. 6-7). Creation such documentation with traditional methods of inspection would take a great deal of time and human resources with lack of detail and accuracy.
